NASA TECHNICAL
MEMORANDUM

NASA TM X-64812

MSFC SKYLAB MULTIPLE DOCKING ADAPTER
Vol. I

Skylab Program Office

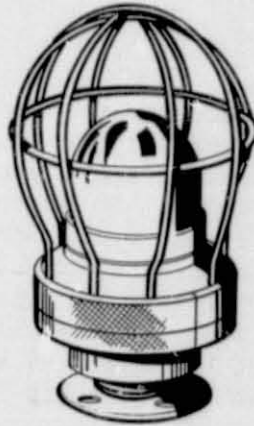
Figure 2.2.4-13 MDA Running Light

B. Functional Description - External running lights were used for gross vehicle attitude determination. They were controlled and activated via the AM/DCS. Running lights were provided to allow determination of coarse vehicle attitude alignment by the crew during rendezvous and docking of the CSM. The running lights were located radially near the MDA outer skin line, but did not interfere with the deployment of the ATM truss as defined in 13M20726. The +Z axis (amber) light was partially obscured by the L-Band truss assembly.

C. Test - The MDA running light system was functionally verified at Denver to procedure MDA-OCP-D-60002, at St. Louis to procedure D3-E72 and at KSC to procedure KS0003. All tests were completed satisfactorily.

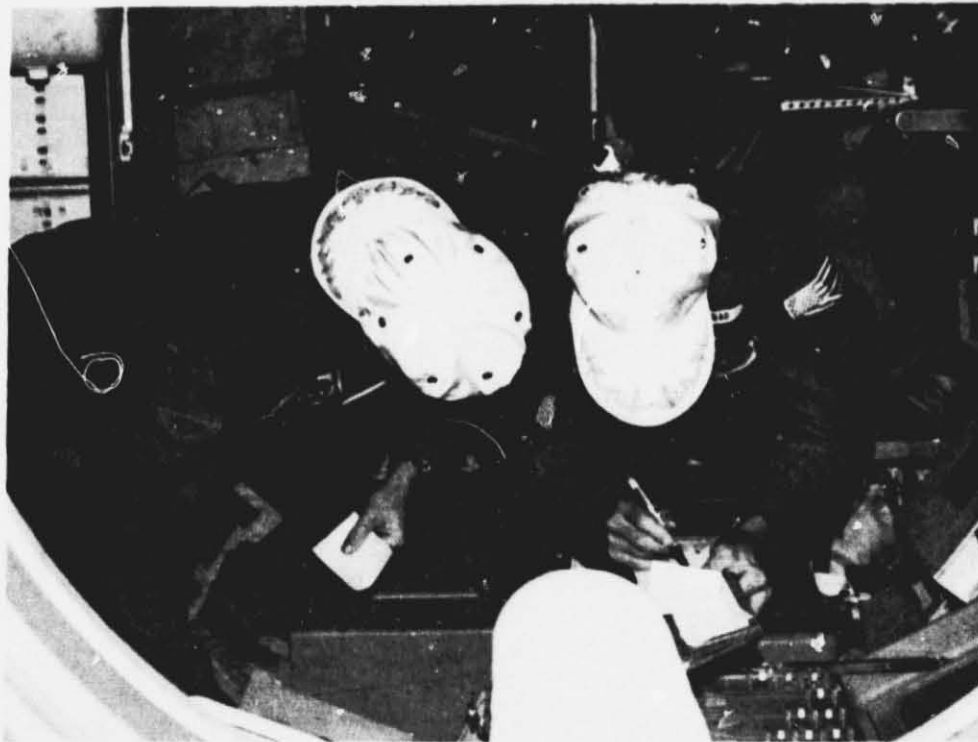
Figure 2.2.9-4 - Skylab Crewmen at EREP VTS and C&D Crew Station

No foot restraint was provided at the VTS crew station. Handholds on the VTS panel were provided for crew positioning and operation at this station. The operator needed to interface with the EREP SIA and the C&D Panel. Neither of these units were positioned to provide this capability from a foot restraint. (A major modification to the MDA equipment arrangement would have been required to configure this station for that capability. A modification of this magnitude was deemed undesirable at that time.)

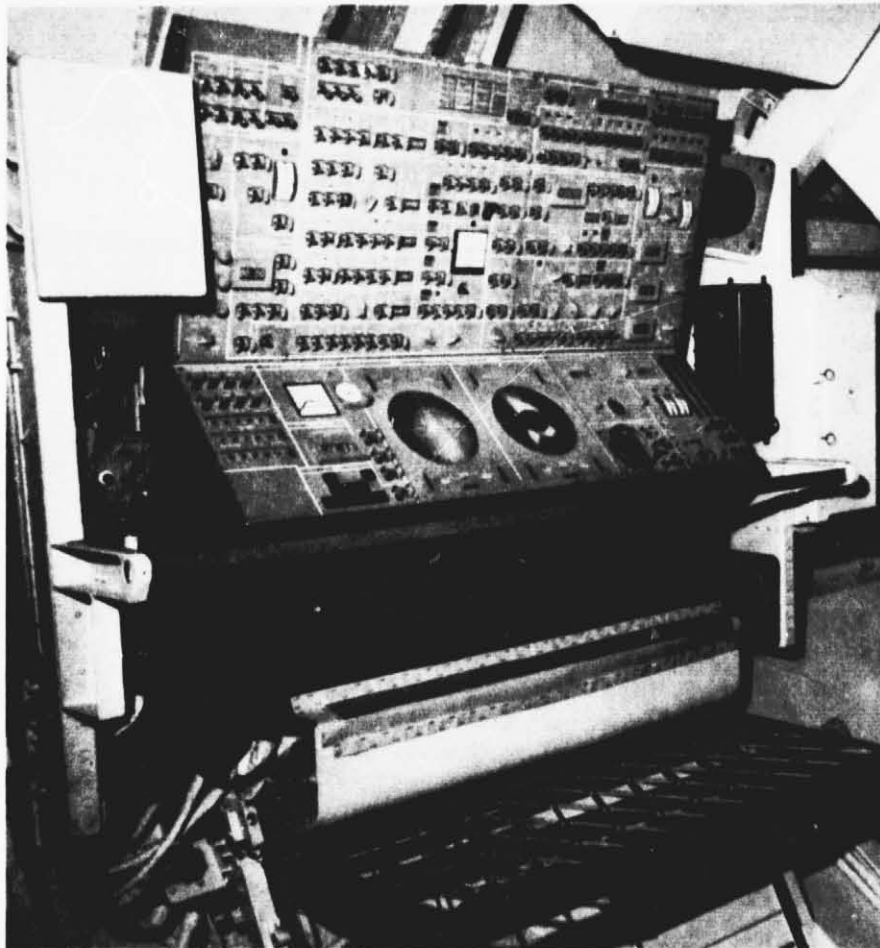
Figure 2.2.10-14 ATM C&D Console
2-395

B. Functional Description - The Control and Display Subsystem, consisting of the C&D Console, the I/LCA, the BI/LCA, the DAS Backup Device, and the RCP provided the crew interface for the operation and management of the ATM experiments and subsystems. This interface was provided primarily by the C&D Console on which the controls and displays required to operate the ATM experiments and subsystems (see Figure 2.2.10-14) were located. Commands were provided to the ATM by toggle and rotary switches, the Manual Pointing Controller and the DAS. Monitoring

was accomplished by the use of status lights and flags, alert lights, dual scale vertical meters, pulse counters, digital displays, an activity history plotter, and TV displays. Additionally, the C&D Console interfaced with the MDA RNEM, providing data recording and monitoring capabilities, and interfaced with the OWS Thruster Attitude Control Subsystem (TACS), providing status monitoring and thruster inhibit command capabilities. All critical command and display functions were implemented through redundant wiring and switching contacts, alternate displays, or were available through the DAS.

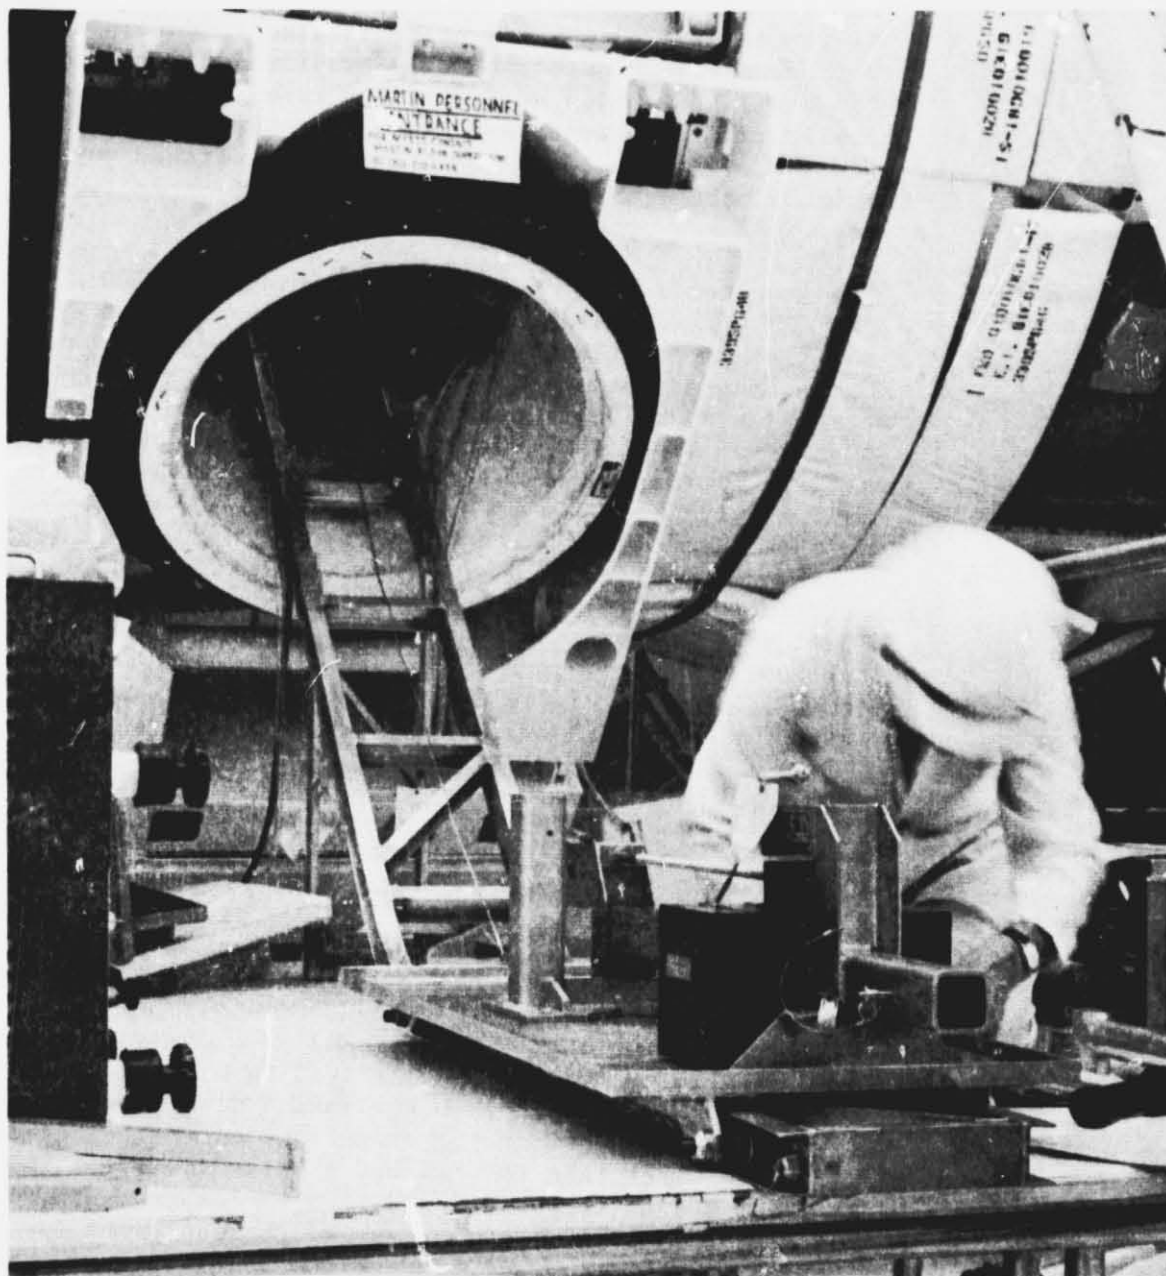
Figure 2.2.11-6 Equipment for Protection and Access
at the Radial Docking Port

In general, proof loading of the covers was not required. An exception was the docking port protective sleeves. These flanged covers lined the full length of the tunnels while providing protection to the docking surfaces and the hatch seal. Used extensively during equipment ingress to the MDA, they also became the sole means of access for personnel into the MDA after the MDA was mated to the AM. See Figure 2.2.11-6.

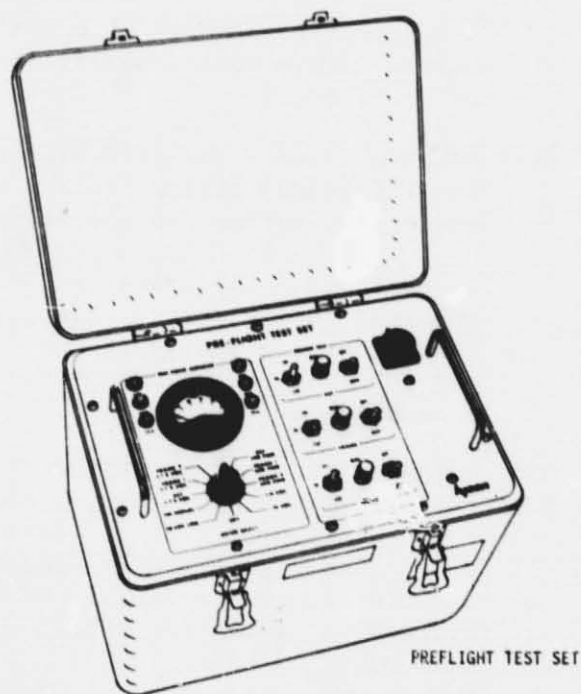
Figure 2.2.11-19 S190 Window Assembly Preflight Tester

G. S190 Window Assembly Pre-Flight Tester, SK820FL7770 (Figure 2.2.11-19).

- (1) Design Requirements - Provide functional checkout capability for the S190 Window Heaters and Controls either on or off module to assure functional integrity of the system.
- (2) Functional Description - The tester was a portable suitcase type test set consisting of a panel assembly and test cable. The panel assembly contained a selector switch and voltmeter to monitor the heater control outputs and resistors. It also
